TROUT RUN DAM NO. 4

NDI I.D. No. PA-00512

PHASE I INSPECTION REPORT
NATIONAL DAM INSPECTION PROGRAM

JANUARY 1980

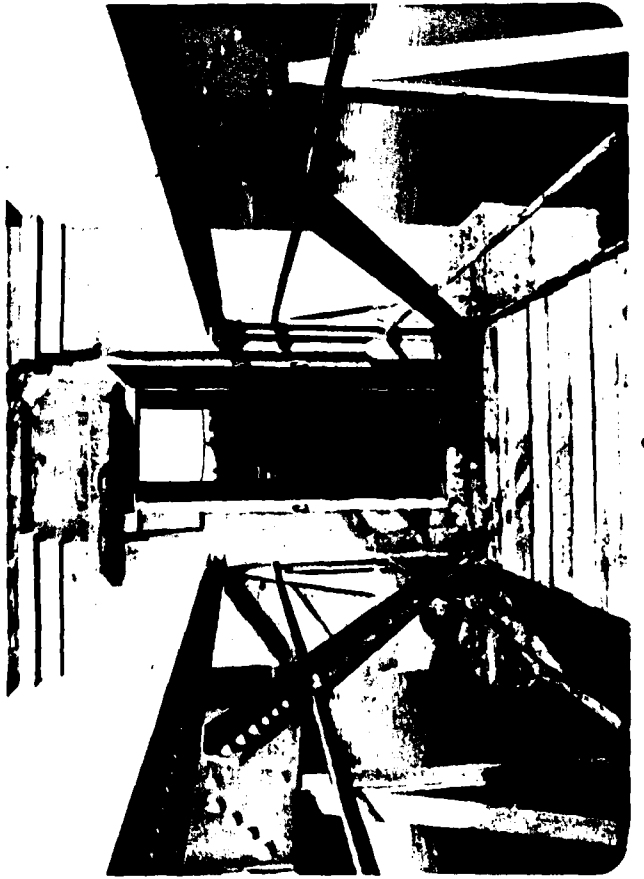
2. Outlet Works. The outlet works are reportedly functional although they were not operated in the presence of the inspection team. The concrete control tower is in fair condition exhibiting minor exterior concrete deterioration (see Photograph 3).

2. Outlet Works. The outlet works are reportedly functional. Concrete deterioration associated with the control tower is considered minor at this time.

PHOTOGRAPH 3 View of the concrete control tower that houses the gate valves for the outlet works.
